## Reduction and Maintenance of Turbochargers by Applying Valid Tribological Constructing

V. Marušić<sup>a</sup>, L. Marušić<sup>b</sup>, M. Samardžić<sup>a</sup>, Ž. Ivandić<sup>a</sup>

<sup>a</sup> *Mechanical Engineering Faculty, Croatia,*

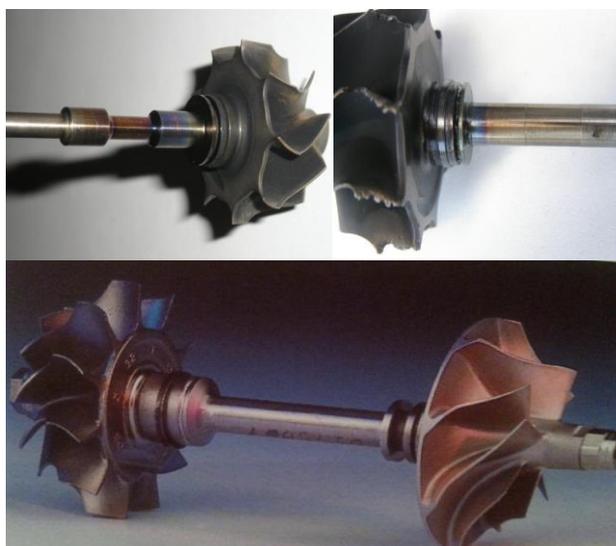
**Fig. 2.** The characteristic appearance of damaged parts of turbochargers.

- there is no visible damage on the housing of turbochargers,
- there is no visible damage on the compressor impeller,
- there is no visible damage on the turbine rotor,
- axle backlash is not increased, and
- visually it was found that the axle changed color, color of the axle towards the rotor blades of the impeller is from purple to dark red.

After the change of color it is clear that there has been overheating, cause of overheating is insufficient cooling, axle is cooled with oil. Cause of damage is bad termination or termination of lubrication [7]. Interruption of lubrication

causes an increase of temperature in the bearings and increase of material wear, it occurs as a result of imbalance of rotating bodies: damage of the rotor and impeller.

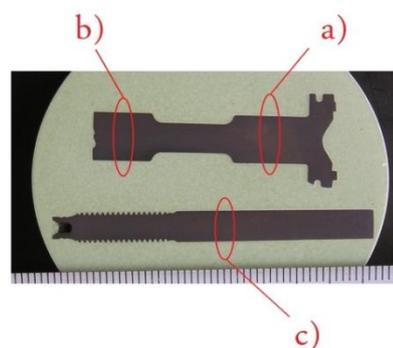
Metallographic examination and measurement of microhardness were performed on the three-section shown in Fig. 3. Results of metallographic tests on the axle of turbochargers have shown that in the heat affected zone has been a change of material structure. Additional measurements of hardness in the impact zone of elevated temperature are indications that there has been a significant local changes in hardness of the surface layer.

**Fig. 3.** Positions of recording structure and micro hardness measurements. A,b,c presents positions where structure was recorded

On the parts of section „b“ and „c“ hardness is between 330 and 350 HV 0,1. On section „a“ (part of axle where you can see purple color) hardness is from 420 to 430 HV 0,1. Figure 4 shows the characteristic microstructure of the damaged axle.

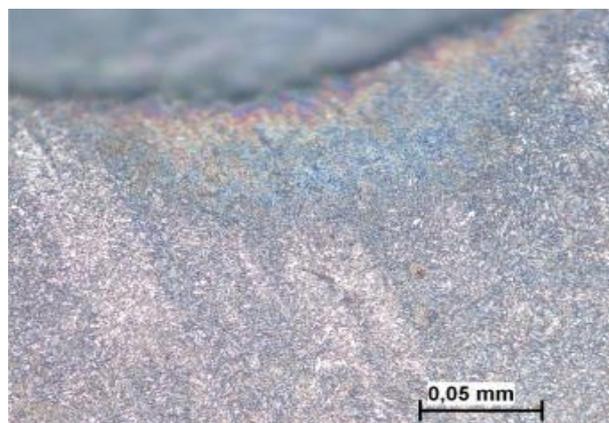
**Fig. 4.** The characteristic microstructure of turbochargers damaged axle, a) damaged surface b) zones of overheating; c) the core.

The measurement results from the Tables 1, 2 and 3 confirm that in the heat affected zone has been a change of the material structure which is manifested by increasing hardness, in a layer located below the hardened layer has been a noticeable decline of decarburization and hardness. Multiple measurements in different areas on the sample can produce results within a large range, due to variations of the surface texture across the sample surface [9,10]. According to the change in the structure we know that the material was exposed to a temperature higher than the temperature of the austenitising.

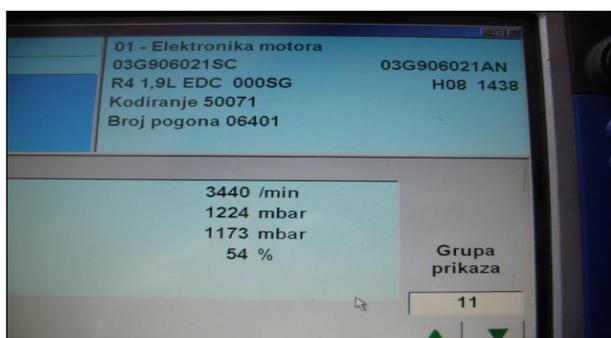
Fig. 6. The pressure and temperature at 3440 rpm.

The temperature of the engine coolant has reached 90 °C, and temperature on the housing slide bearing was 219.2 °C. For safety reasons, rpm of the engine was no longer supported, but the test shows that the temperature rapidly increases depending on rpm. The maximum is 6000 rpm.

The critical temperature at which the oil begins to fall apart at the lighter components and coke is quite low and only 360 °C, which does not satisfy. The results of the tests indicate that in extreme temperature conditions turbochargers may exceed the permissible temperature of the oil of 360 °C.

1. Sensor for temperature of turbochargers which would not allow shutdown of the power aggregate until the temperature is lower and acceptable.
2. Separate lubrication system of the sliding bearing that is not connected to the lubrication system of the drive unit, with custom lubrication and with a separate cooling and drive pump that continues to work after stopping the drive unit.
3. Cooling housing of turbochargers with liquid which cools drive unit. In this solution, the problem is that the engine coolant temperature is 90 °C, and the temperature of the exhaust gas of the turbochargers is much higher and would require adjustment cooling system with larger refrigerators and plenty of coolant.
