# Tribological Investigation of The Effect of Aluminum Alloy in Accordance with Cast Iron Liner on Engine Wear

The tendency to use aluminum alloys to replace conventional gray cast irons (GCI) materials in engine blocks of passenger cars is gaining more and more importance driven by reduction of engine weight to achieve expectation for lowering fuel consumption and CO<sub>2</sub> emissions. In this work the tribological effect of new produced aluminum engine cylinder liner is compared with the conventional cast iron the cylinder bore for friction, lubrication and wear-resistance. Their tribological performance was evaluated through a reciprocating tribometer, using steel ball (100 CR6) on an aluminum and cast iron Diesel engine cylinder liners with 5W-40 engine oil to investigate their wear and friction behavior in boundary lubrication regime. There is a great effect of the roughness of machining marks (honing) on the surface of the liner. Although the same honing type was applied on both liner sleeves, aluminum liner presented less wear track, less roughness smoother surface related to cast iron liner. Repeated friction tests presented almost similar coefficient of friction data.

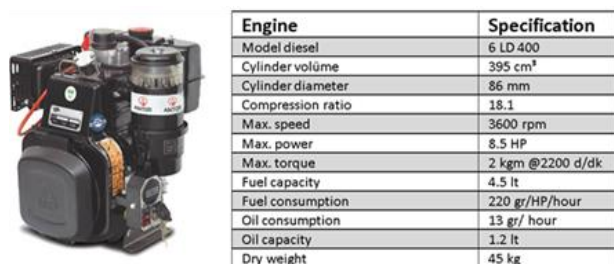
Fig. 1. Anadolu motor Antor 6 LD 400 diesel engine and its technical specifications.

Anadolu Motor Antor LD400 Diesel engine has been chosen for this work. Its technical specifications are presented in Figure 1. It is air cooled and single cylinder engine.

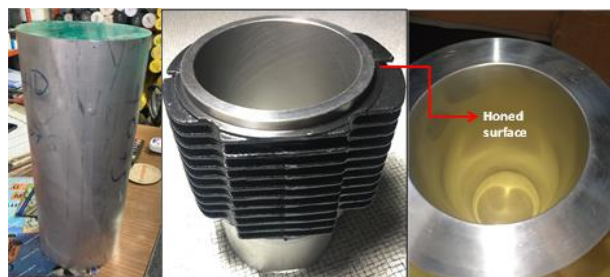
Fig. 3. Aluminum block drilled and honed as the same of Anadolu motor Antor 6 LD 400 diesel engine.

Aluminum material standard is EN AW-7075/ ISO (Al Zn5,5MgCu) as the chemical composition is presented in Table 1. Figure 3 shows the aluminum block drilled and honed as the same of Anadolu Motor Antor 6 LD 400 Diesel engine.

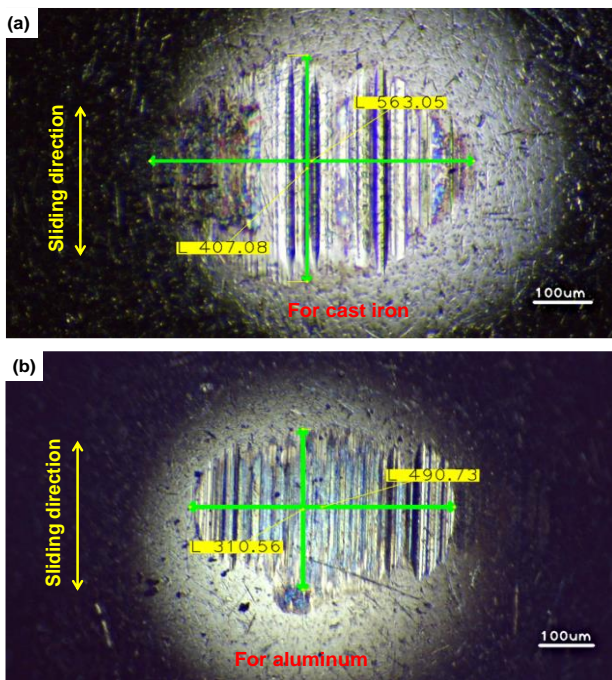
**Fig. 9.** Optical digital images of the wear scar diameter (horizontally and vertically) of the balls tested on the (a) cast iron and (b) aluminum liner with 5W40 engine oil.

Figure 9 presents the optical digital images of the wear scar diameter (horizontally and vertically) of the balls tested on the (a) cast iron and (b) aluminum liner with 5W40 engine oil. As seen in table 3, surprisingly wear scar diameter of the ball presented lowest value horizontally and vertically on aluminum liner related to the cast iron liner.

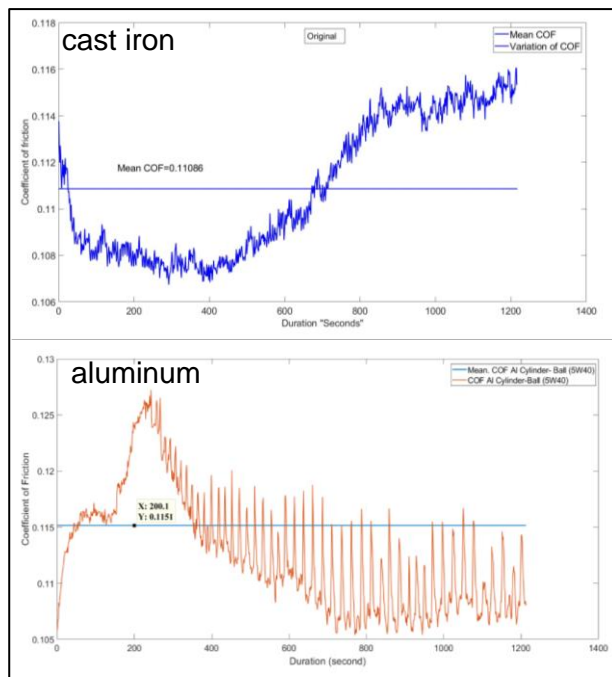
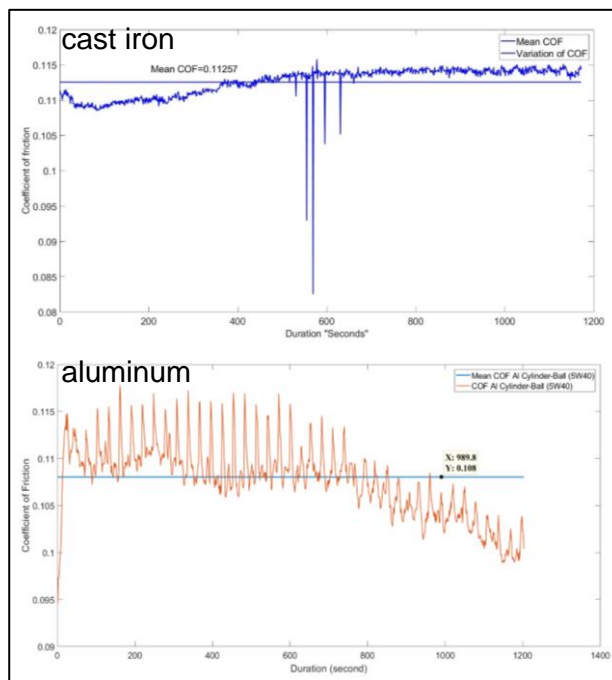
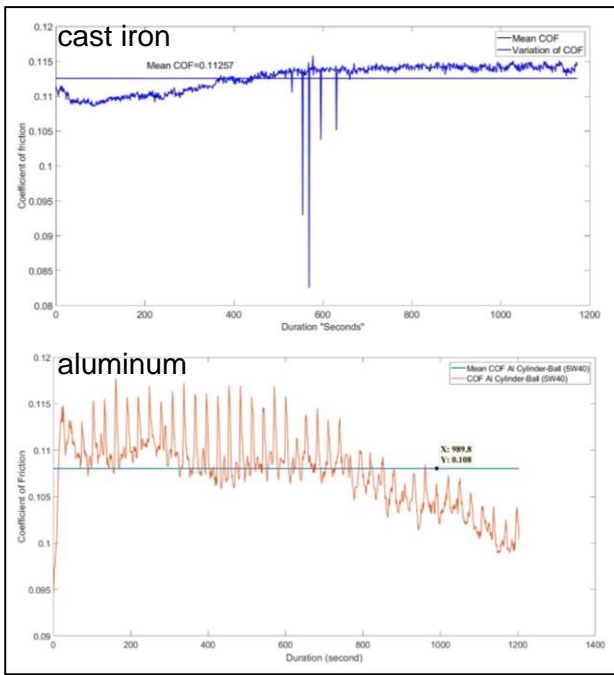
Average of COF of three tests of Figures 15,16,17 is increased as 1.449% in aluminum liner as showed in Figure 18.

**Fig. 15.** Plotting and average CoF values obtained after experimental reciprocating tribotest of the first test with cast iron and aluminum cylinder liner using engine oil (5w40).

**Fig. 16.** Plotting and average CoF values obtained after experimental reciprocating tribotest of the second test with cast iron and aluminum cylinder liner using engine oil (5w40).

**Fig. 17.** Plotting and average CoF values obtained after experimental reciprocating tribotest of the third test with cast iron and aluminum cylinder liner using engine oil (5w40).

3. We can say that friction coefficient is almost the same and it is increased only 1.449% for aluminum liner. This is usual as aluminum is lighter than cast iron,

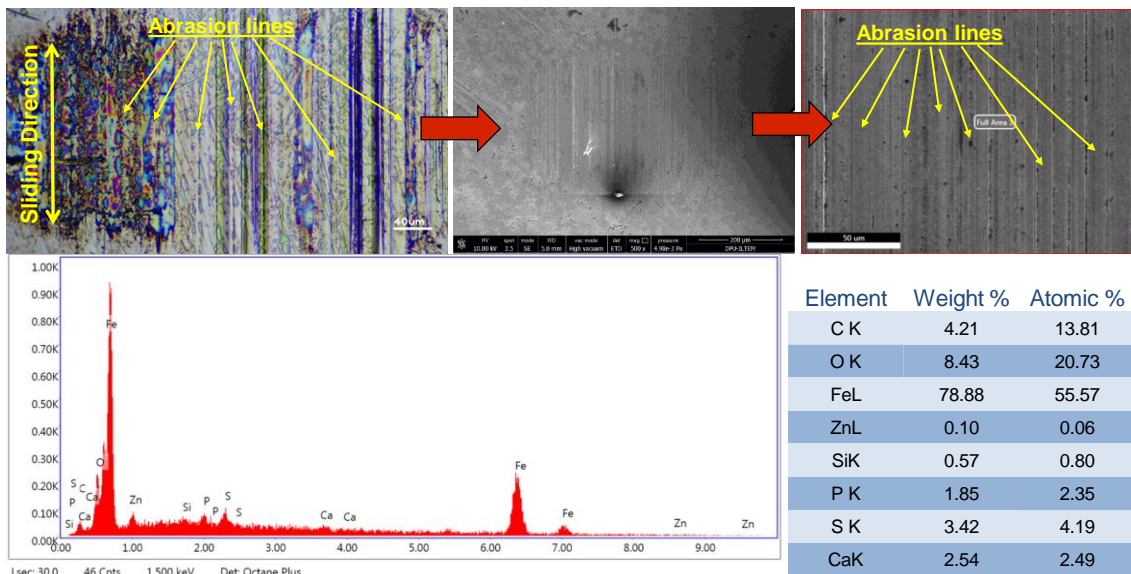
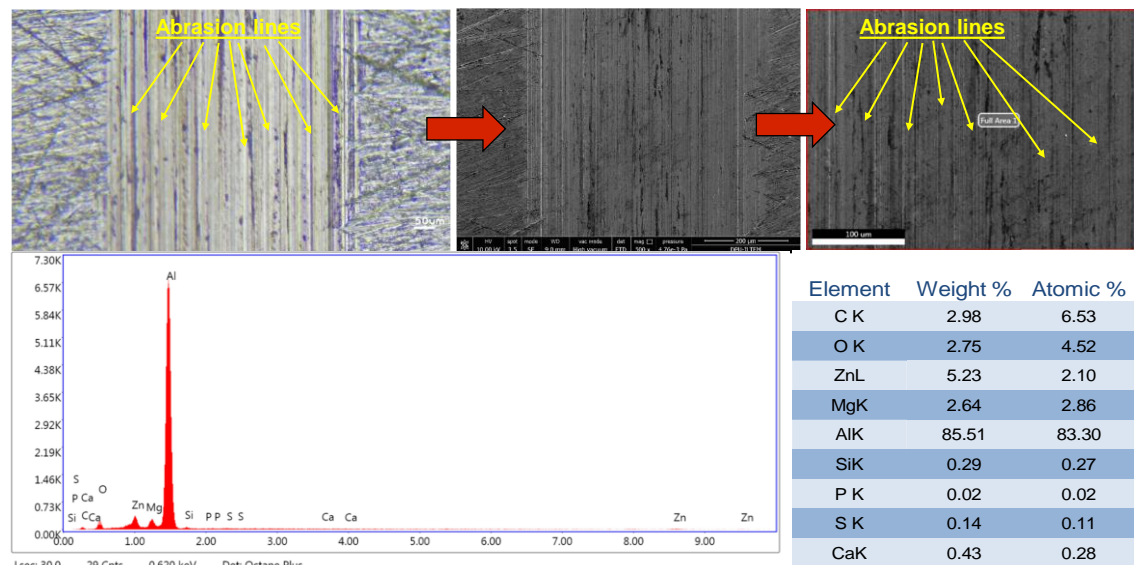
**Fig. 19.** SEM image with elemental analysis of the rubbed surface of the ball rubbed on the cast iron liner tested with 5W40.

It is evident that additional protection to rubbing surfaces from wear was provided, due to the formation of a protective layer, represented by colorful regions, as displayed in the first optical microscopy images of the Figures 19, 20, 21, 22 [5].

Fig. 20. SEM image with elemental analysis of the of the tested cast iron liner under steel ball.

Fig. 21. SEM image with elemental analysis of the rubbed surface of the ball rubbed on the aluminum liner tested with 5W40.

Fig. 22. SEM image with elemental analysis of the of the tested aluminum liner under steel ball.

5. The main reason is the homogeneous plastic deformation which makes the surface smooth and reactive providing better surface degradation, this allows quick surface reaction between the lubricants and sliding pairs for the test of aluminum liner because additives such as Zn, Ca, P content mixed with it and formed protective layers.
