An Experimental Investigation and Improvement of Insulated Rail Joints

F.A. Elshukri^a, R. Lewis^a

^aUniversity of Sheffield, Sheffield, UK.

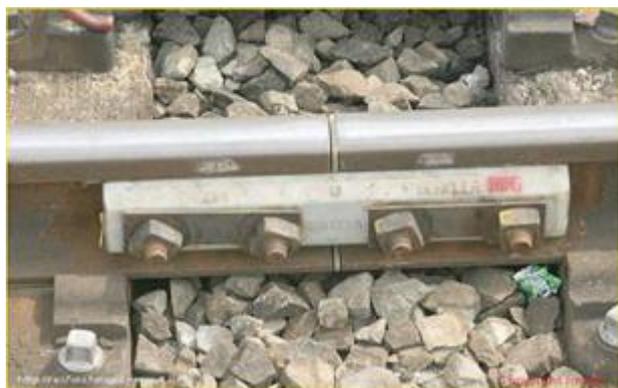
Fig. 1. Insulated Rail Joints (IRJs) [6].

Insulated rail joints (IRJs) are one of the essential parts in track circuits. They contain from two fishplates bolted to each side of the rail and an insulating material layer (end post) is placed in the gap between the adjacent rail ends as can be seen in Fig. 1. IRJs are employed as part of signalling system. They are used to connect adjoining rails and make the rail network electrically isolated and dividing into track circuits [1]. IRJs are considered to be weak point in the rail track [2]. IRJs failure is a serious safety case. The steel parts such as the joint bars and bolts may break and the rail head material may flow both due to excessive load from wheels

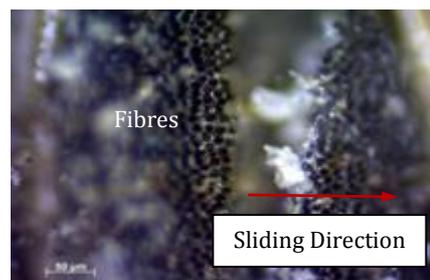
Fig. 18. Contact Surface of EG in Dry Test at 7.2 m/sec and 50 N.

Epoxy Glass Material: the material wear resistance gradually decreased due to an increase of sliding speed from 1.5 m/sec to 7.2 m/sec at a load of 30 N (see Fig. 6). The worn contact surface was coarse. Fibres and scratches were observed on the surface. The wear resistance of the material reduced significantly when the sliding velocity rose from 1.5 m/sec to 7.2 m/sec at a load of 50 N as shown in Fig. 7. This is in agreement with Chowdhury [12]. The wear surface was more roughened and severe deterioration of fibre surface was observed due to the rise in temperature as shown in Figure 18. The material wear resistance was better in the case of wet test condition as seen in Figures 8-10. These happened because contact temperature reduced. The worn surface became smooth and the wear damage to be fibres exposed and scratches parallel to sliding direction (see Fig. 19).

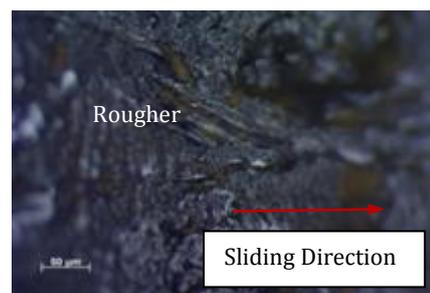
Fig. 20. Contact Surface of PRBF in Dry Test at 7.2 m/sec and 50 N.

of 50 N as seen in Fig. 20 and the wear surface was smooth (see Fig. 16). This is in agreement with Myshkin [10]. This was due to thermal wear. In contrast, there was a positive effect of water on material wear resistance in case of wet tests condition compared with dry tests condition as shown in Figs. 8-10. The wear surface was more smoothed, cracks were observed and scratches existed on the surface (see Fig. 17).

3.3 m/sec at a load of 30 N (see Fig. 6). The worn surface became partly rough due to increase in temperature and groove marks are appeared on the surface. While the material wear resistance decreased massively when sliding speed increased to 7.2 m/sec at loads of 30 N and 50 N as shown in Fig. 20. The worn surface was rough due to rise in the contact temperature (see Fig. 20). The material wear resistance rose significantly in case of wet tests condition compared with that in dry tests condition as seen in Figs. 8-10. The sources of wear damage to fibre, smears and scratches parallel to sliding direction as shown in Fig. 21.
