Investigations on Wear Behaviour of AISI 4140 Hot Strip Mill Roller Hardfaced with Martensitic Stainless Steel by Submerged Arc Welding Process

R.V. Patel^{a,*}, S.P. Wanare^a, V.D. Kalyankar^a

^aMechanical Engineering Department, Sardar Vallabhbhai National Institute of Technology, Surat, 395007, Gujarat, India.

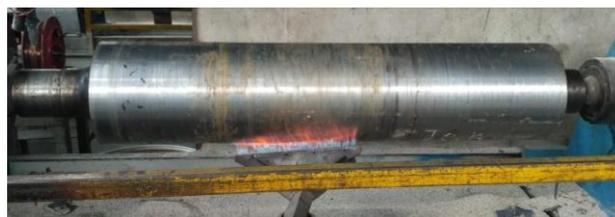
**Fig. 2.** Preheating of the roller

Now, AISI 4140 steel is prone to cracking due to its poor weldability therefore preheating is very essential to avoid cracks and PWHT also require in order to relieving the stress. Now, the carbon content and alloy content of the substrate metal are two major factors that affect preheat temperature and also, the substrate material has martensite transformation temperature range between 280°C to 350°C. Therefore, to prevent substrate material from cracks, preheating of roller is carried out at 250°C as shown in Fig. 2 and maintained as an interpass temperature throughout the hardfacing of roller as shown in Fig. 3. Three multi-track layers are deposited on the substrate material having thicknesses of approximately 3.5 mm each. Similar procedure is followed for both the hardfacings.

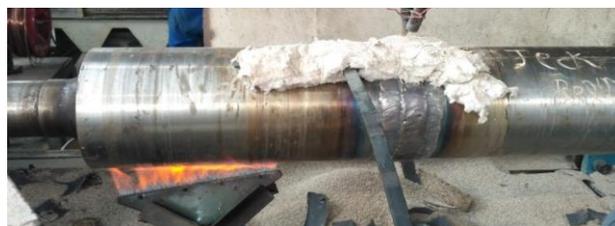
**Fig. 3.** Hardfacing process of roller

SAW under direct current reversed polarity was employed for deposition of hardfacings. The welding conditions are as follows: welding voltage 30-35 V, welding current 420-460 A, wire extension 15-20 mm, welding speed 10-12 meter/hour and overlap rate was 8-12 % of hardfaced layer width. Turning process is performed before deposition of hardfacing to remove cracks, uneven roundness, foreign particles on the surface of the roller, etc. Further, the die penetration test is performed to check the quality of surface as shown in Fig. 1.

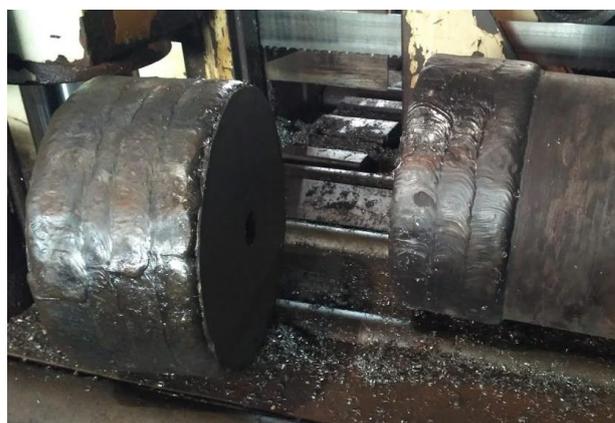
**Fig. 4.** Cut down portion of hardfaced roller

PWHT produces tempered martensite which is accepted as an ideal combination of strength and toughness for hot strip mill roller. Therefore, PWHT of hardfaced roller is carried out with heating of roller for 12 hours up to 580°C temperatures. Later on, the soaking of the roller is carried out for 8 hours to achieve a uniform temperature throughout the roller thickness. It is then followed by furnace cooling to reach up to the room temperature, which takes around 8 hours. Further, the hardfaced portion of the roller is cut-down for sample preparation as shown in Fig. 4.

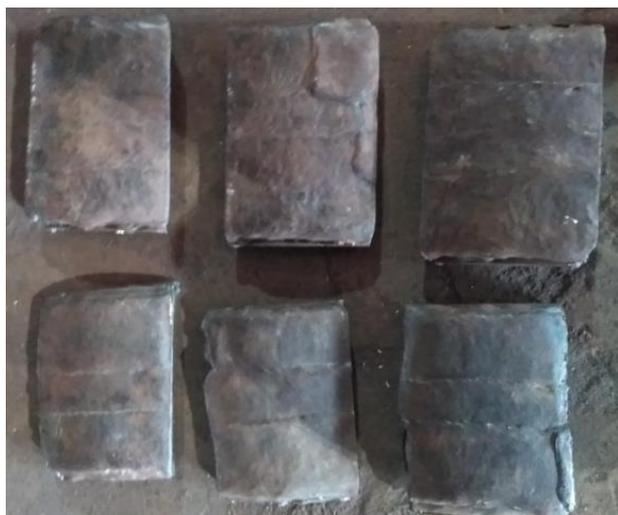
Fig. 5. Samples cut from the roller

As shown in Fig. 5, the hardfaced portion of the roller is cut down further into a rectangular shape. In Fig. 5, there are three samples of each H1 hardfacing and H2 hardfacing. Samples are prepared with different thicknesses to analyze wear resistance and hardness properties at different thicknesses of hardfaced surface as shown in Fig. 6.

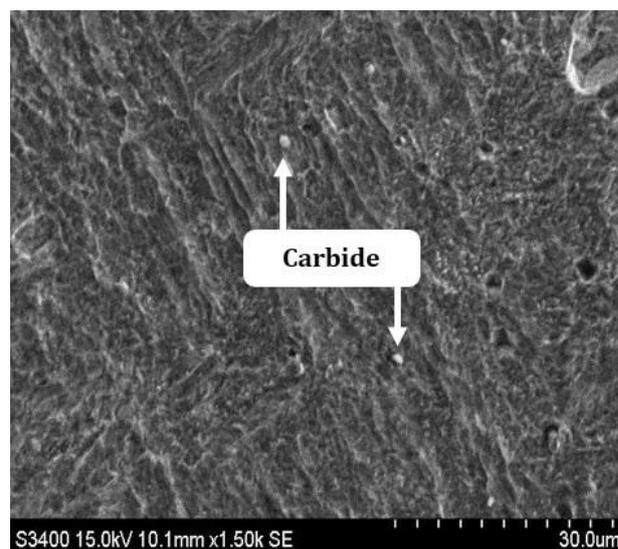
Fig. 14. SEM micrograph of specimens (a) H2-3, (b) H2-2, (c) H2-1, (d) H1-3, (e) H1-2, (f) H1-1

In order to correlate the obtained wear characteristics, an in-depth study of a worn-out surface is also attempted with SEM. The specimen which exhibits the lowest wear resistance is selected for this purpose as represented in Fig. 14.

The martensite structure formed in hardfacing material does not indicate that the morphology of samples under the slurry abrasion test give crack or fracture. The microstructure of different layers is shown in Fig. 12 and Fig. 14. It was observed that as thickness of hardfacing increases, the finer size of martensite and carbide are formed. Also, the wear test data indicates that the finer phases of martensite and carbides are resulted into relatively higher abrasion wear mass loss as compared to coarser martensite and carbides as similarly reported by E. Badisch and C. Mitterer [32].

elements at specific point. At all specified points in Fig. 13, the percentage of chromium and iron are significantly higher than other elements. Hence, the precipitate form in hardfacing samples might be Fe/Cr carbide [36]. The SEM micrograph of hardfacing materials are shown in Fig. 14. A large volume of fine-sized carbide particles is presented in the hardfacing of H2 wire as shown in Fig. 14 (a). While in the H1 hardfacing, a small volume of carbide phase with coarse size is found on the grain boundaries as shown in Fig. 14 (d). The formation of carbide phase can be found more in H2 hardfacing in comparison to H1. The micrographs of the hardfacing samples revealed lath martensite, retained austenite and carbide precipitates as shown in Fig. 14 (c). As observed from the microstructure, a few portions of the martensitic structures have been transformed to ferrite and other carbides [37]. The size of carbide formed in H1 hardfaced samples can be found larger than H2 samples as shown in Fig. 14 (c) and Fig. 14 (f).
