Microstructural Evolution and Strain-Hardening Behavior in Hadfield Steel Railway Crossings

This work examines defect (spalling) in a railway crossing (frog) removed from a heavy-haul railway after 120 Milling Gross Tons (MGT). The frog was manufactured using standard Hadfield steel. The steel microstructure evolution was analyzed to understand crack initiation and propagation during service. Scanning electron microscopy (SEM), X-ray diffraction, and electron backscattered diffraction (EBSD) methods were employed to characterize microstructural changes near the crack region. Furthermore, local mechanical properties were assessed using nanoindentation tests and sub size tensile tests. SEM analysis revealed that twinning is the primary work-hardening mechanism, with the absence of phase transformation confirmed by XRD. The interaction of dislocation walls and twin structures generated by twinning-induced plasticity increased the local hardness of Hadfield steel up to 8.5 GPa, substantially reducing ductility. Peak broadening of austenite phases was observed, indicating significant crystal defect densities under cyclic loading. Microstructural analysis in defect regions showed that t

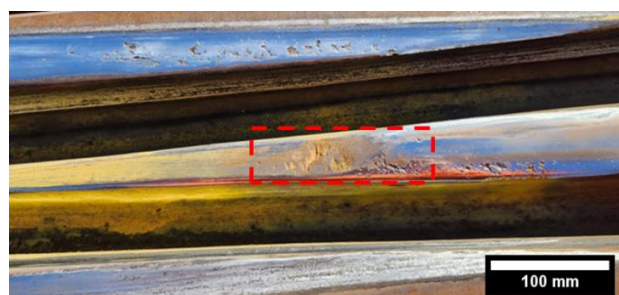
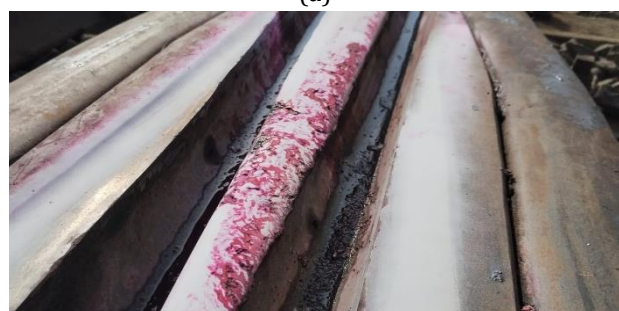
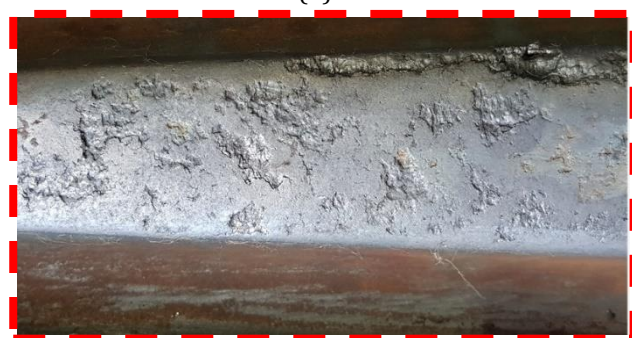
A railway crossing (Figure 2) applied to a Heavy-Haul railway was analyzed after 120 MGT (Milling Gross Tons), not subjected to any prior hardening process (by explosion). The region of the crossing analyzed was the nose (Figure 2a), which had Spalling-type defects in severe condition (Figure 2c), making it possible to observe the density of cracks and defects using the liquid penetrant test (Figure 2b). The crossing was fabricated with Hadfield Steel with the chemical composition presented in Table 1, as specified by ASTM A-128 for grade B [20].

Fig. 2. (a) Identification of the spalling-type defect in a railway crossing, (b) nose of the crossing after liquid penetrant test and (c) Spalling-type defects in higher magnification.

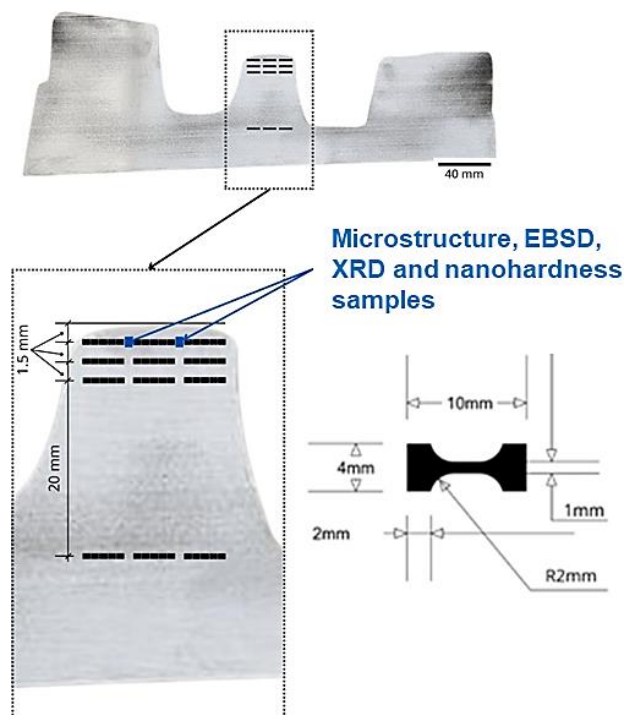
Fig. 3. Cross-section of the crossing analyzed, analysis and sample collection regions and subsize sample geometry.

Figure 3 shows sample collection regions of the railway crossing for microstructure, EBSD, XRD, nano-hardness and tensile test analyses.

For the nano-hardness analysis, a Berkovich indenter at 1mN normal load was used. The micro-tensile test, with subsize specimens, were conducted in an Instron 3369 testing machine at a constant strain rate of 10^{-3} s^{-1} from the yield point to fracture. Bluehill® software was used to control the test parameters and data acquisition. Three test replicate was employed. The samples were manufactured by wire electrical discharge machining, with a thickness of 1 mm and a length of 10 mm (Figure 3c).

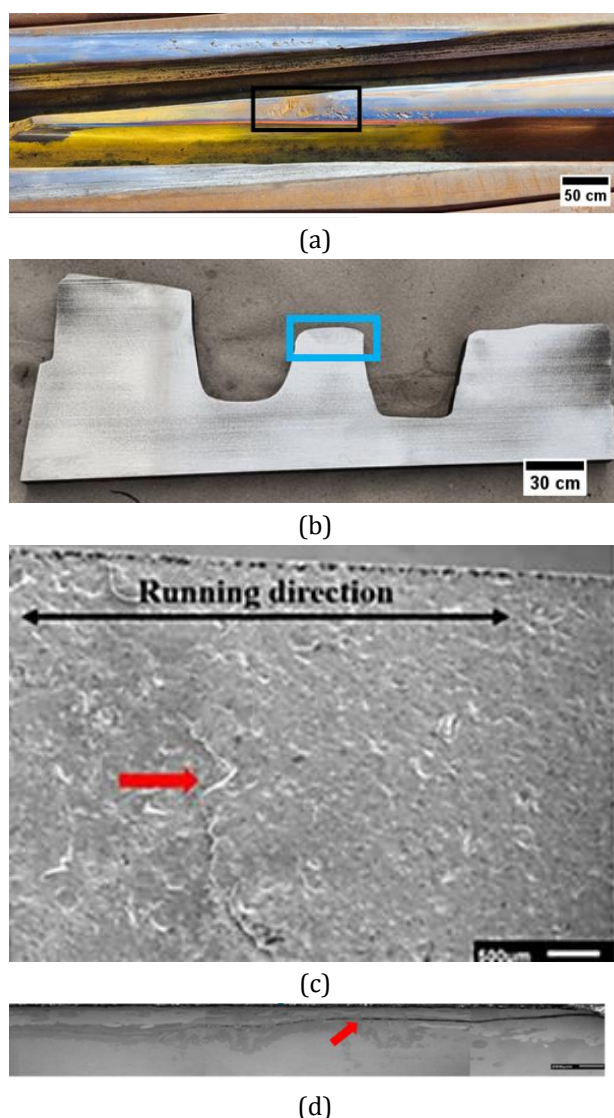
For the characterization of the microstructure beneath the surfaces, SEM analysis was conducted on the running band of the crossing (Fig. 4). The surface on the top of the crossing exhibited spalling failure and surface cracks (see Fig. 4c). A cross-sectional view of the microstructure revealed two distinct regions within the same sample, characterized by crack propagation parallel to both the surface and the base of the spalling (Fig. 4d).

Fig. 4. Sample identification, (a) Hadfield crossing, (b) cross section of analyzed region, (c) worn surface on the top of the crossing (SE-SEM micrograph), (d) microstructure in the cross-section of the worn surface. The crack propagation is identified by the red arrows and the spalling area by the black box.

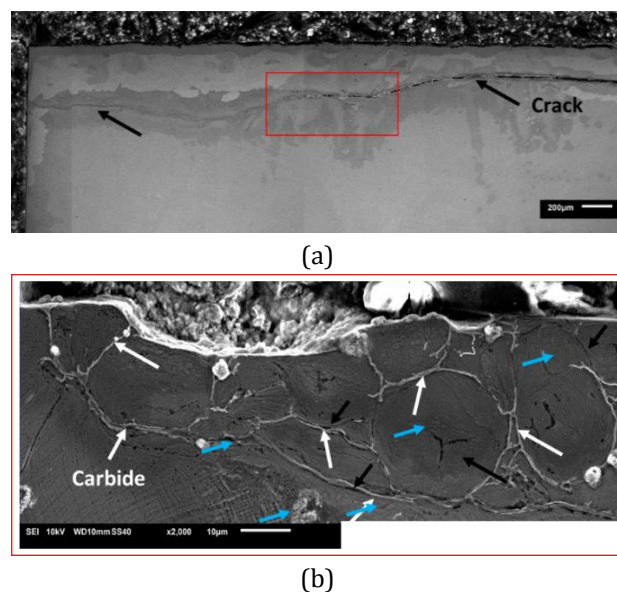
Figure 5 displays the cross-sectional microstructure of the area containing the crack analyzed via SEM. The red box highlights a specific region close to the crack, revealing a significant number of secondary cracks (black arrows) and the presence of continuous carbides along the grain boundaries (white arrows). In regions where carbides are present along the grain boundaries, some cracks can be observed, acting as stress concentrators, reducing fracture toughness and making these regions preferential sites for crack nucleation and propagation [21,22]. Additionally, from the cross-sectional analysis in Figure 5b, it is possible to notice areas with cracks at an early

stage and the presence of carbides, suggesting that cracks are nucleated in these carbide-rich regions. Precipitated carbides decrease impact and fracture toughness, and as a result, the component, in this case, the crossing, may not withstand the impacts and stresses imposed by the railway wheels. Carbides were observed in almost all regions analyzed. In the central regions, where heat dissipation is more difficult, higher fractions of carbides were observed.

Fig. 5. SEM micrograph of the microstructure in cross section of the worn surface showing, a) a surface crack propagating in parallel direction throwing the microstructure, b) formation of twins in the region close to the crack. Formation of secondary cracks.

To enhance the metallurgical quality of crossings with carbide precipitates, several actions can be proposed: controlling the chemical composition and adopting an appropriate solubilization heat treatment. Reducing carbon content tends to decrease the propensity for carbide formation, while adding molybdenum extends the cooling time required, preventing carbide precipitation after solubilization treatment [22,23]. Solubilization heat treatments aim to dissolve phases, such as perlite and carbides, until the microstructure becomes entirely austenitic. To guarantee the complete dissolution of undesirable phases and prevent carbide formation, the temperature, heating time, and cooling rate must be adequately adjusted [23]. The formation of surface defects on this crossing is likely associated with the nucleation and propagation of cracks in carbide-rich regions, leading to the removal of large volumes of material.

Despite the cracks observed in Figure 5b, the Hadfield steel was able to absorb some of the energy and deformed, as evidenced by the twinning deformation mechanisms (blue arrows).

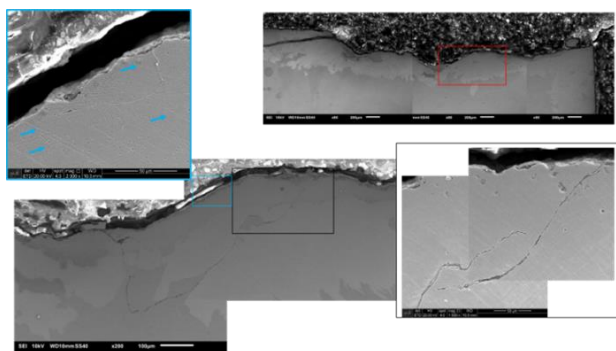
Figure 6 and Figure 7 present the cross-sectional microstructure of the spalling area. The presence of spalling can be associated to the surface cracks nucleation and the propagation through a work-hardened region close to the surface. The red box in Figure 6 highlights the microstructure, identifying the crack propagation in the region near the surface. The FEG-SEM micrograph (blue and black boxes) enables the identification of twins (blue arrows) as the primary deformation mechanism in the subsurface area. Figure 7 provides a detailed view of the twinning mechanism near the worn surface. The formation of a high density of deformation twins is evident. These twins are a key factor in strain-hardening, leading to the dynamic Hall-Petch effect, which results in ultrafine grain formation and increased hardness near the surface [24].

Fig. 6. Microstructure in the cross section of the worn surface with a surface crack. The red box shows the microstructure highly magnified, highlighting microstructure features like the crack junction (red arrow). The blue and black boxes show the formation of twins in the region close to the surface.

The figure illustrates that crack propagation is primarily transgranular, which is consistent with the literature [25] on deformation mechanisms in Hadfield steel under cyclic loading and impact conditions. The interaction between dislocations and deformation twins plays a crucial role in strain-hardening. Figures 5 to 7 demonstrate that the microstructural changes due to repeated stress and impact are characterized by crack nucleation at grain boundaries rich in carbides and the development of twinning structures. This suggests that the work-hardening mechanisms, particularly twinning, are responsible for increasing hardness near the surface, but they also contribute to crack formation and propagation.

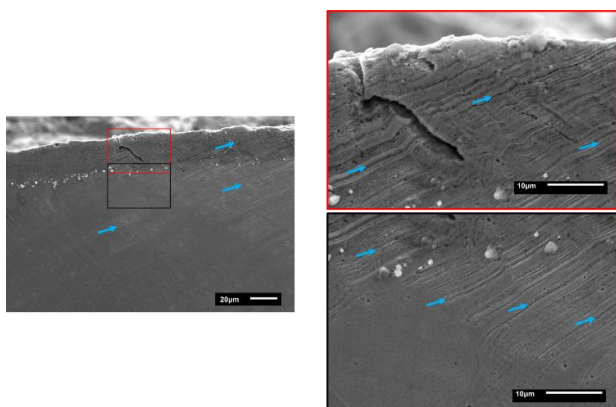
Fig. 7. Microstructure in the cross section showing the twin in the region close to the worn surface.

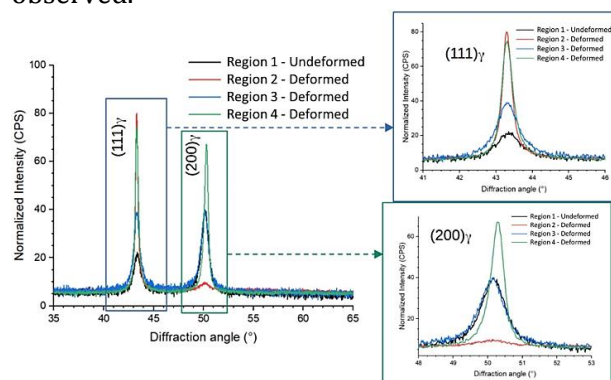
Figure 8 reveals that only austenite was identified. XRD patterns exhibit peaks of (111) and (200) planes corresponding to FCC austenite [9,26]. Although the micrographs displayed the presence of carbides in the grain boundary, XRD did not detect these phases due to their small quantity compared to austenite. Additionally, other phases, such as martensite induced by deformation in this type of steel, were not observed.

Fig. 8. XRD patterns in different regions of the crossing.

To investigate phase transformations induced by deformation, XRD analyses were conducted in various regions of the crossing, both near the worn surface (Regions 2, 3, and 4 – deformed regions) and in the bulk of the crossing (Region 1 – undeformed region).

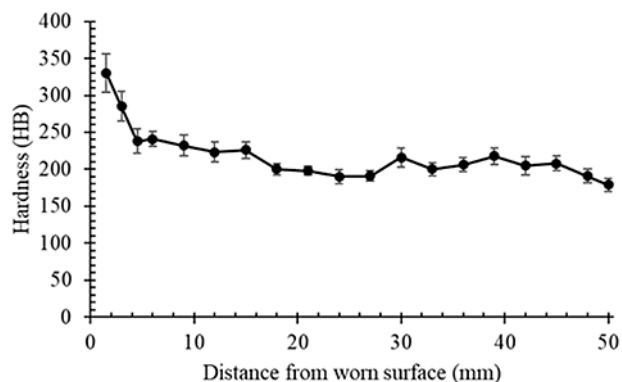
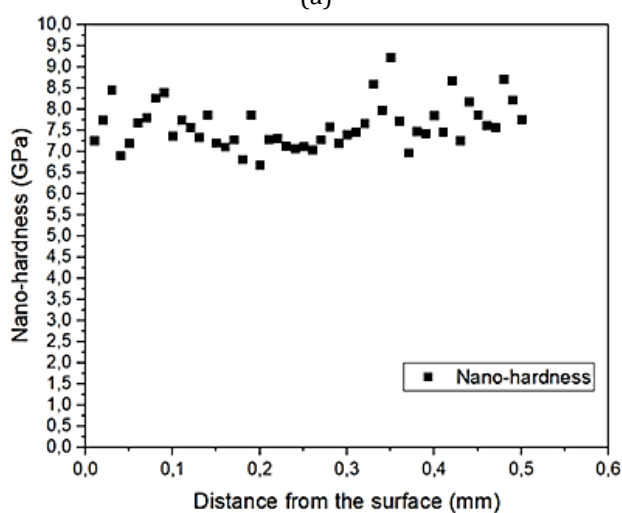
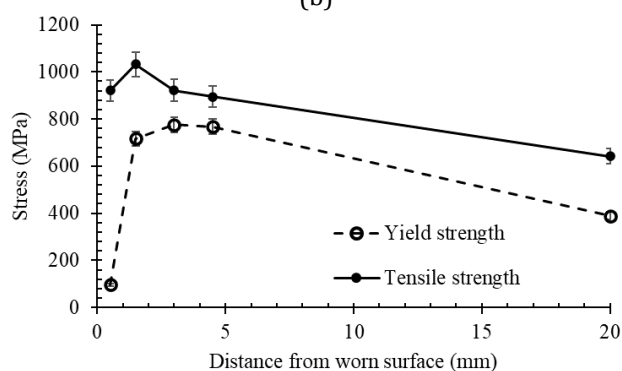
Hardness analysis in the subsurface, as function of the distance from the worn surface, reveals strain-induced hardening in the region close to the surface. The hardness profile indicates that hardening reaches a depth of approximately 8 mm. The maximum macro hardness found, of 350

HB, was in the region closest to the surface, at approximately 1.5 mm. To understand in more detail the hardening of layers closest to the wear surface, nanohardness profile was carried out between 0.01 and 0.5 mm, from the surface.

Fig. 9. (a) Hardness profile, (b) Nano-hardness profile and (c) tensile test results as function of the distance from the worn surface.

The results indicates that the nanohardness reaching an average value of 8 GPa up to 500 μ m depth (see Figure 9b). Similar hardness was found in Hadfield steels subjected to wear in

crushers [27], in railway crossing [10] and in laboratory sliding wear test [9]. The hardness of the material without deformation, located 50 mm from the worn surface, measured 200 HB. Comparing these hardness values, the deformed region exhibited a hardness 3.5 times higher. The tensile test results (Figure 9c) demonstrated that both yield and tensile strength limits are sensitive to the material's deformation level. In the region of higher deformation, that is, closer to the worn surface, yield strength and tensile strength were lower than in other regions of the material. It is suggested that, in this region, the material's deformation capacity had already been exhausted due to the demands imposed by the wheel and the presence of cracks, which drastically reduce the properties of the area. However, in intermediate regions between the worn and the core surface (without deformation), the values were higher. This outcome indicates that the material in these regions, with lower deformation intensities, still possesses the capacity to absorb energy and respond to the demands imposed by the passing of railway wheels.

The results of tensile tests (Figure 9c) are important to reinforce and justify preventive maintenance interventions on the crossings. The application of the preventive grinding process can be important, considering that the region closest to the surface has lower mechanical properties and that the adjacent layer has better mechanical properties compared to the surface and the core (material without deformation). Therefore, for railway practice, maintenance teams can limit the amount of material to be removed preventively, with the aim of removing part of the cracks and exposing a region of the material that has higher deformation capacity, and consequently greater resistance to wear.

Preventive rail grinding is a practice commonly applied on the world's main Heavy-Haul railways. This process guarantees the partial removal of RCF defects, as well as ensuring the correction of the rail profile, thus safeguarding a contact that allows for a better stress distribution. However, grinding of crossing is generally carried out in a corrective practice, often applied when the defect has already propagated and is at an advanced stage. The results found in this work show the importance of designing a grinding practice taking

precautions at crossings, in order to avoid large spreads of cracks and also remove a region of the material that not has the capacity to absorb the deformation imposed by the wheel contacts.

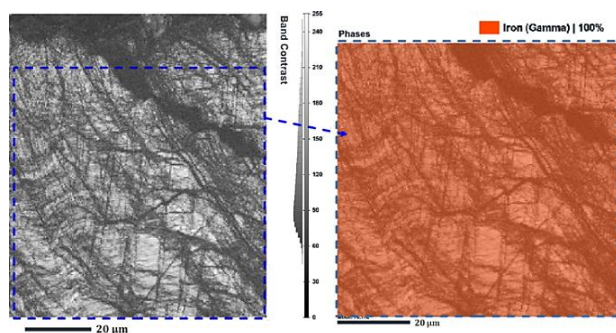
The EBSD analysis at the subsurface region, extending to 100 μm below the surface, provides significant insights into the accumulative plastic deformation occurring beneath the contact area. Figure 10 illustrates the initiation and propagation of cracks. These cracks initially nucleated at the contact interface between the train wheel and the rail surface due to the cumulative effects of fatigue impact and rolling contact stresses. As previously discussed, this region experiences extreme accumulative deformation, leading to a high concentration of defects, which accelerates the formation of microcracks. The band contrast image in Figure 10 highlights the formation of highly localized shear bands and FeMn twinning structures. However, it is important to note that FeMn twins could not be directly detected by EBSD, as the Kikuchi patterns and phase maps in this image solely reveal the presence of austenitic FCC- γ phases. The inability to detect FeMn twins through EBSD is attributed to the inherent limitations of the technique in identifying specific twinning within the FCC structure [28,29]. It is worth mentioning that the FCC crystal structure, which has the highest atomic packing factor (74%), is analogous to the HCP unit cell. Severe plastic deformation, as a result of extensive slippage, can alter the atomic packing configuration, leading to the formation of local defects. These defects, in turn, can result in HCP-type twinning, as observed in this figure.

Fig. 10. Band contrast and phase maps at the subsurface region, illustrating the initiation and propagation of cracks beside the formation of highly localized shear bands and FeMn twinning structures.

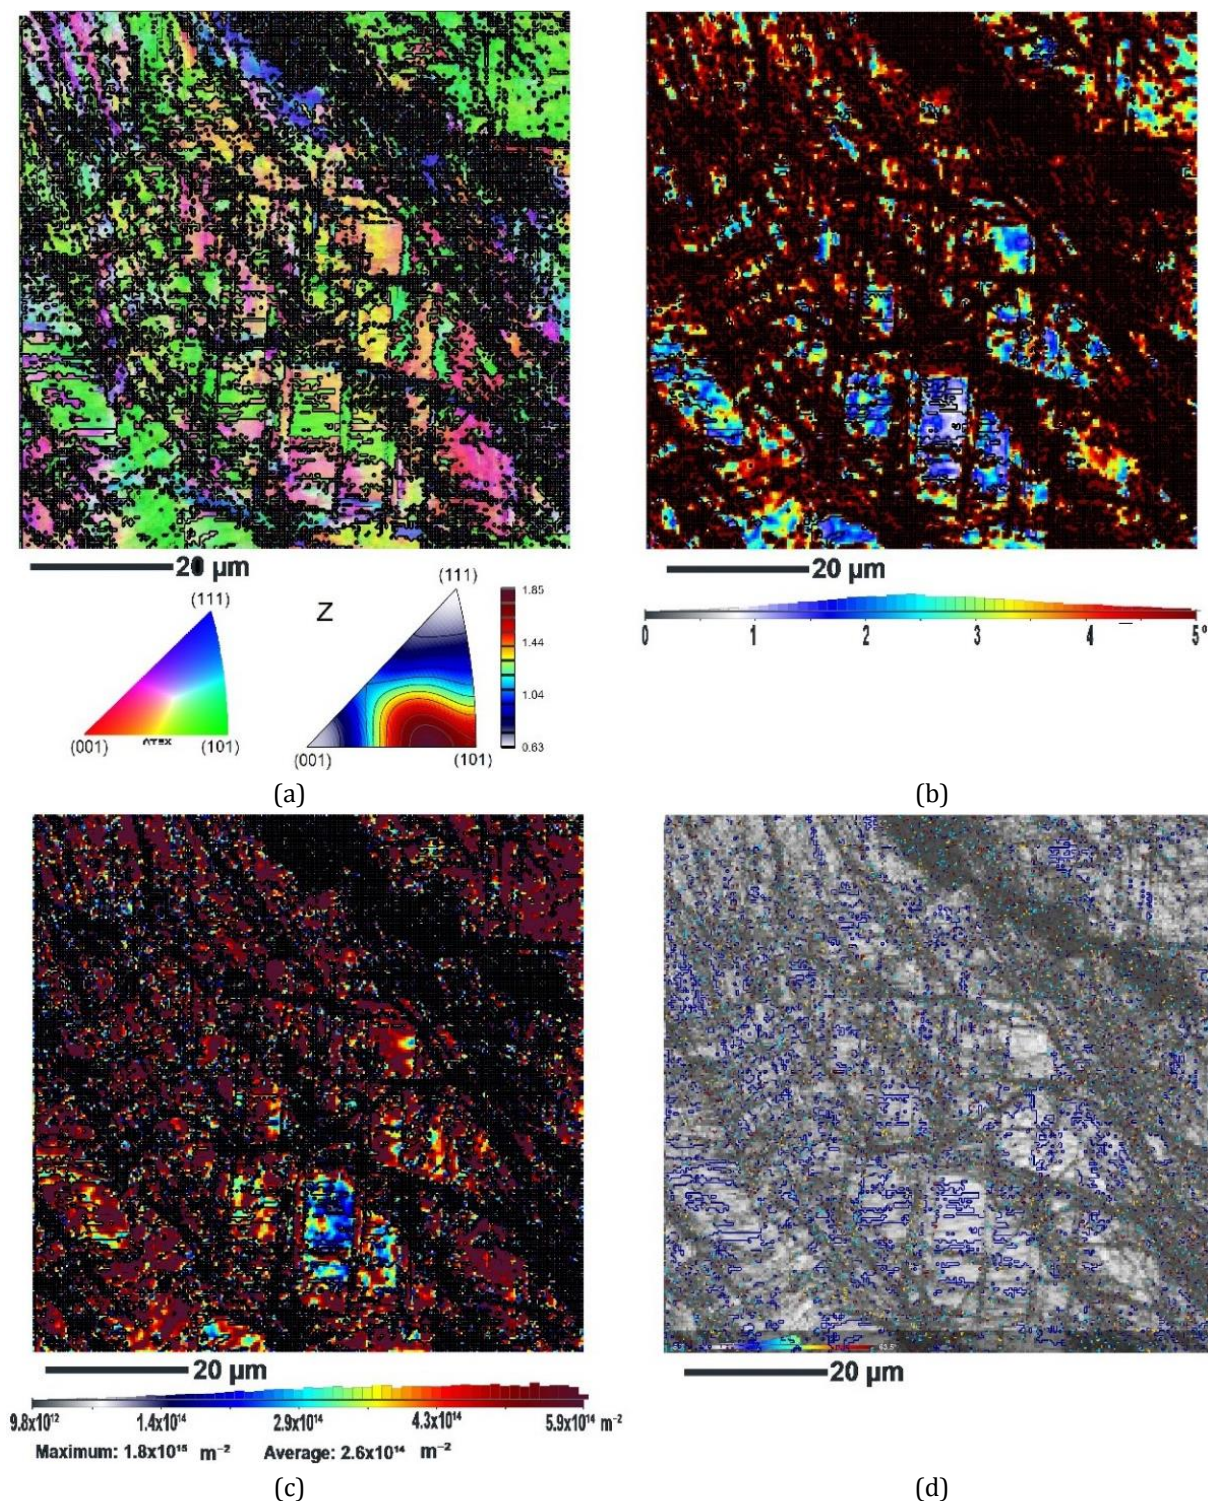
Figure 11a presents the Z-direction Orientation Image Map (Z-OIM) of the longitudinal rail direction. In this map, cracks and twin interfaces are represented in black due to the absence of Kikuchi patterns, which inhibits their detection. Nevertheless, the color-coded map effectively illustrates the crystal and grain orientations. Visual inspection, along with statistical analysis using the Z-Inverse Pole Figure (Z-IPF) map, confirms the predominant crystal orientations of (102) to (101) within the FCC- γ matrix. It is well established that the $\langle 101 \rangle$ direction is the most densely packed atomic orientation, primarily facilitating atomic plane sliding during plastic deformation, which accounts for the observed twinning. The image suggests that crack propagation occurs along the (101) grain boundary, likely driven by the high Schmid factor associated with this orientation.

Figure 11b displays the Kernel Average Misorientation (KAM) map, which quantifies grain internal distortion by calculating the misorientation of the five nearest pixels relative to a reference point, with a threshold of 5° to minimize the influence of grain and subgrain boundaries [30]. The regions exhibiting high KAM values, indicated in red, clearly demonstrate significant internal energy within the material. Figure 11c illustrates the crystallographic defect densities as determined by the Entrywise Norm of the Nye Tensor. This analysis reveals that the average dislocation density is approximately $7.6 \times 10^{14} \text{ m}^{-2}$, with a peak density reaching around $1.8 \times 10^{15} \text{ m}^{-2}$, which is exceptionally high for Hadfield steel [10,21]. These findings suggest that while the material performs well under operating conditions, adjustments during maintenance periods may be necessary to manage the high defect densities effectively. During the deformation process of Hadfield steel, the work hardening and strength of the material increase, but the fracture strain decreases, resulting in ductility loss, promoting the occurrence of microfractures [31], which evolve into spalling-type defects shown in the Figure 2c. As shown in the tensile tests (Figure 9b), dislocation density measurements also suggest that regions closer to the surface need to be removed by preventive procedure, exposing regions with a greater capacity to absorb the stresses imposed by wheel contact.

Fig. 11. (a) Z-OIM, (b) KAM, (c) crystallographic defect densities, and (d) $\Sigma 3n$ special boundaries maps obtained from EBSD data.

between grains can be described by Axis/Angle pairs, such as $\Sigma 3$ twins, which represent a 60° rotation around the $\langle 111 \rangle$ axis, or $\Sigma 9$ with a 38.94° rotation around $\langle 110 \rangle$. Euler angles are another way to describe grain orientations, often used in EBSD analysis. Figure 11d shows that 10.2% of the total boundary length (28,900 μm)

in the EBSD map consists of twin-related special boundaries. Among these, 7.21% correspond to $\Sigma 3$ (60° around $\langle 111 \rangle$), 1.31% to $\Sigma 9$ (38.94° around $\langle 110 \rangle$), 0.58% to $\Sigma 27a$ (31.59° around $\langle 110 \rangle$), and 1.12% to $\Sigma 27b$ (35.43° around $\langle 210 \rangle$), demonstrating the prevalence of $\Sigma 3$ twins under plastic deformation.

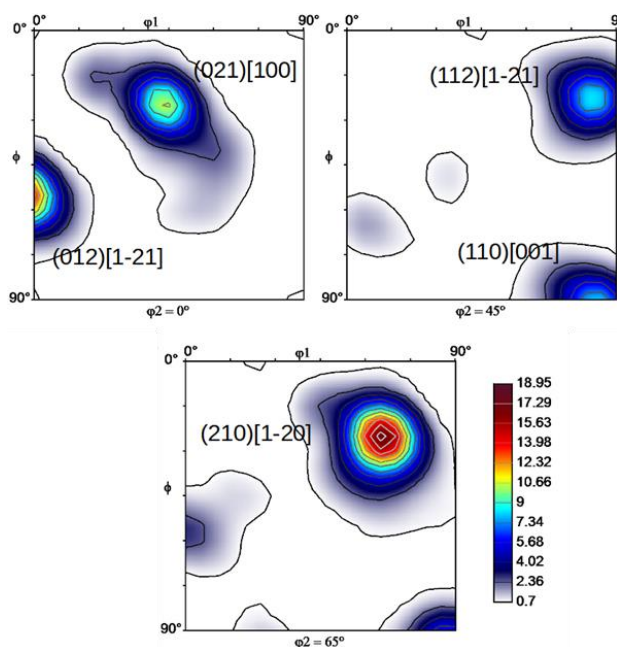
Fig. 12. ODFs at constant $\phi_2=0^\circ$, 45° , and 65° to present the most known crystallographic textures

ODF from individual orientations was done by kernel density estimation using Fourier series on the orientation space that associates to each orientation volume percentage of crystals in the obtained EBSD data. Figure 12 shows ODFs at constant $\phi_2=0^\circ$, 45° , and 65° to present the most known crystallographic textures in FCC structure materials [32]. The (210) [1-20] and (012) [1-21] crystallographic textures were estimated with the highest volumetric fraction at the predominant texture in this region, where the (210) atomic plane is parallel to the rolling direction, while [1-20] and [1-21] were estimated as atomic directions parallel to the rolling direction. The significant presence of these orientations suggests a strong correlation with the twinning phenomenon, as these specific crystallographic textures align closely with the conditions that favor twinning in FCC structures. The [1-20] and [1-21] directions are likely to be involved in the activation of twinning on the $\{111\}$ planes due to their alignment with the twinning shear direction, leading to the formation of twin boundaries.

This alignment not only facilitates atomic plane slippage but also promotes the nucleation and growth of twins, thereby contributing to the observed texture and the mechanical behavior of the material under rolling conditions [33]. The high Schmid factors associated with these orientations further justify their role in enhancing twinning activity, ultimately influencing the overall deformation mechanisms in the FCC matrix.
