# Investigation of Failures in a Belt Conveyor Shaft Coupled by an Expansion Ring

Fretting wear  
Fretting fatigue  
Conveyor belt  
Shaft failure  
Expansion ring

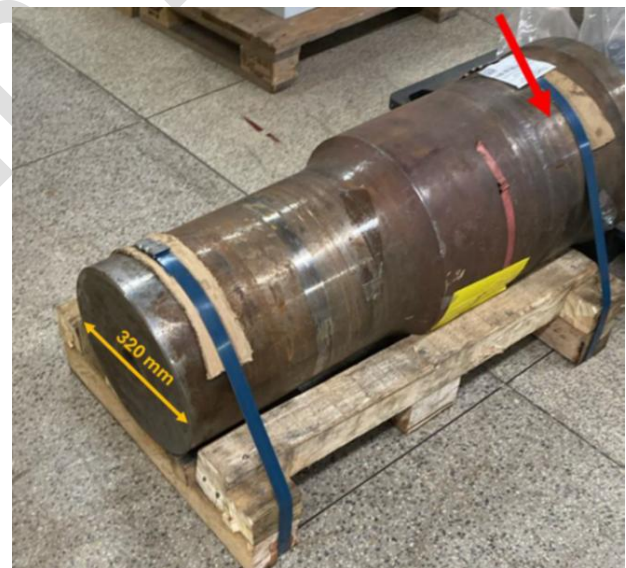
**Fig. 4.** The selected shaft.

The selected shaft is shown in Figure 4. Initially, the shaft was inspected using liquid penetrant testing in order to detect the presence of cracks (arrow red) and to allow their identification and dimensional characterization. Subsequently, the shaft was sectioned for further examination. Two regions of the shaft were analyzed, both located within the contact zone with the locking assembly. One region corresponded to the area where the crack was detected, while the second region, positioned at the opposite side of the shaft

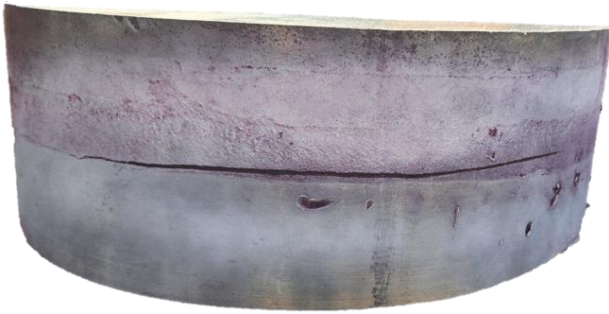
After sectioning the conveyor pulley shaft, the region of interest was examined by liquid penetrant testing. A crack extending over approximately one-third of the shaft circumference was identified, as illustrated in Figure 6.

**Fig. 6.** Conveyor pulley shaft examined with liquid penetrant test.
