## Reduction and Maintenance of Turbochargers by Applying Valid Tribological Constructing

V. Marušić<sup>a</sup>, L. Marušić<sup>b</sup>, M. Samardžić<sup>a</sup>, Ž. Ivandić<sup>a</sup>

<sup>a</sup> *Mechanical Engineering Faculty, Croatia,*

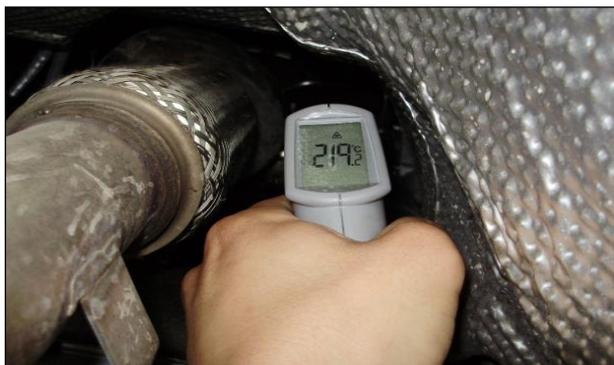
Fig. 5. Testing the turbocharger.

Testing of the working conditions at the temperature of normal load showed that the

temperature does not exceed the extreme limits. Testing is performed on the work table, Fig. 5, at heavy load of turbocharger, 3440 rpm, Fig. 6.

The critical temperature at which the oil begins to fall apart at the lighter components and coke is quite low and only 360 °C, which does not satisfy. The results of the tests indicate that in extreme temperature conditions turbochargers may exceed the permissible temperature of the oil of 360 °C.
